Technical Memorandum

Interim Report on Cold Brook Natural Nitrogen Attenuation Project

Re: Interim Report on Cold Brook Natural Nitrogen Attenuation Project, Harwich, MA

Date: January 29, 2015

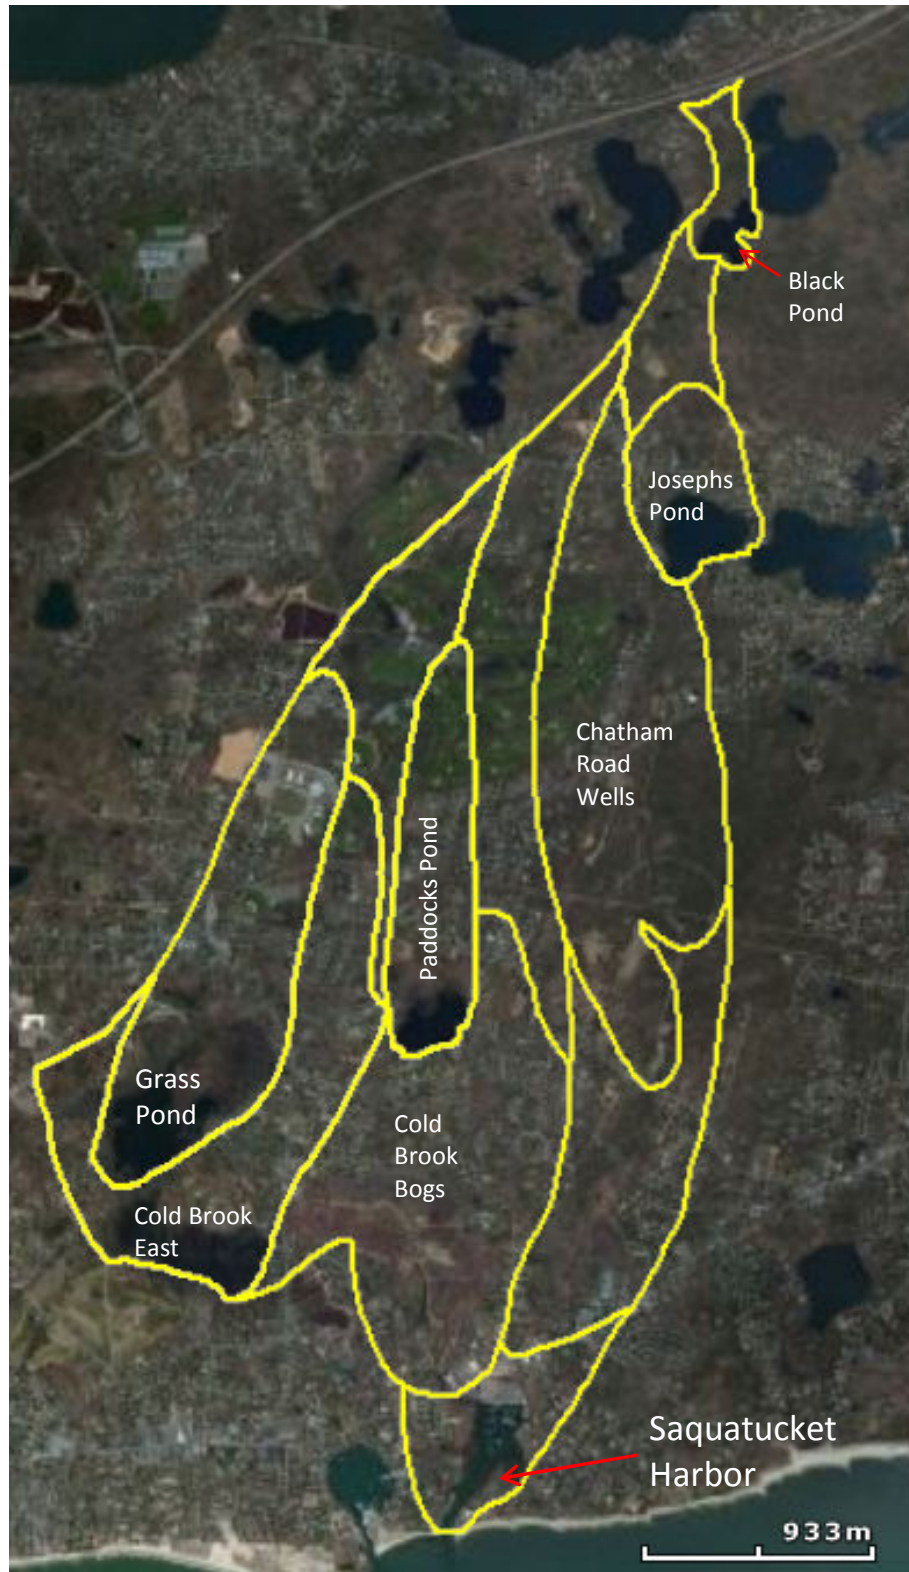
Figure 2. Saquatucket Harbor Watershed. Watershed from 2010 MEP report and shows subwatersheds to ponds, public water supply wells, and streams within the overall Harbor watershed system. Streamflow measurements at Hoyt Road confirm the estimated watershed flow.

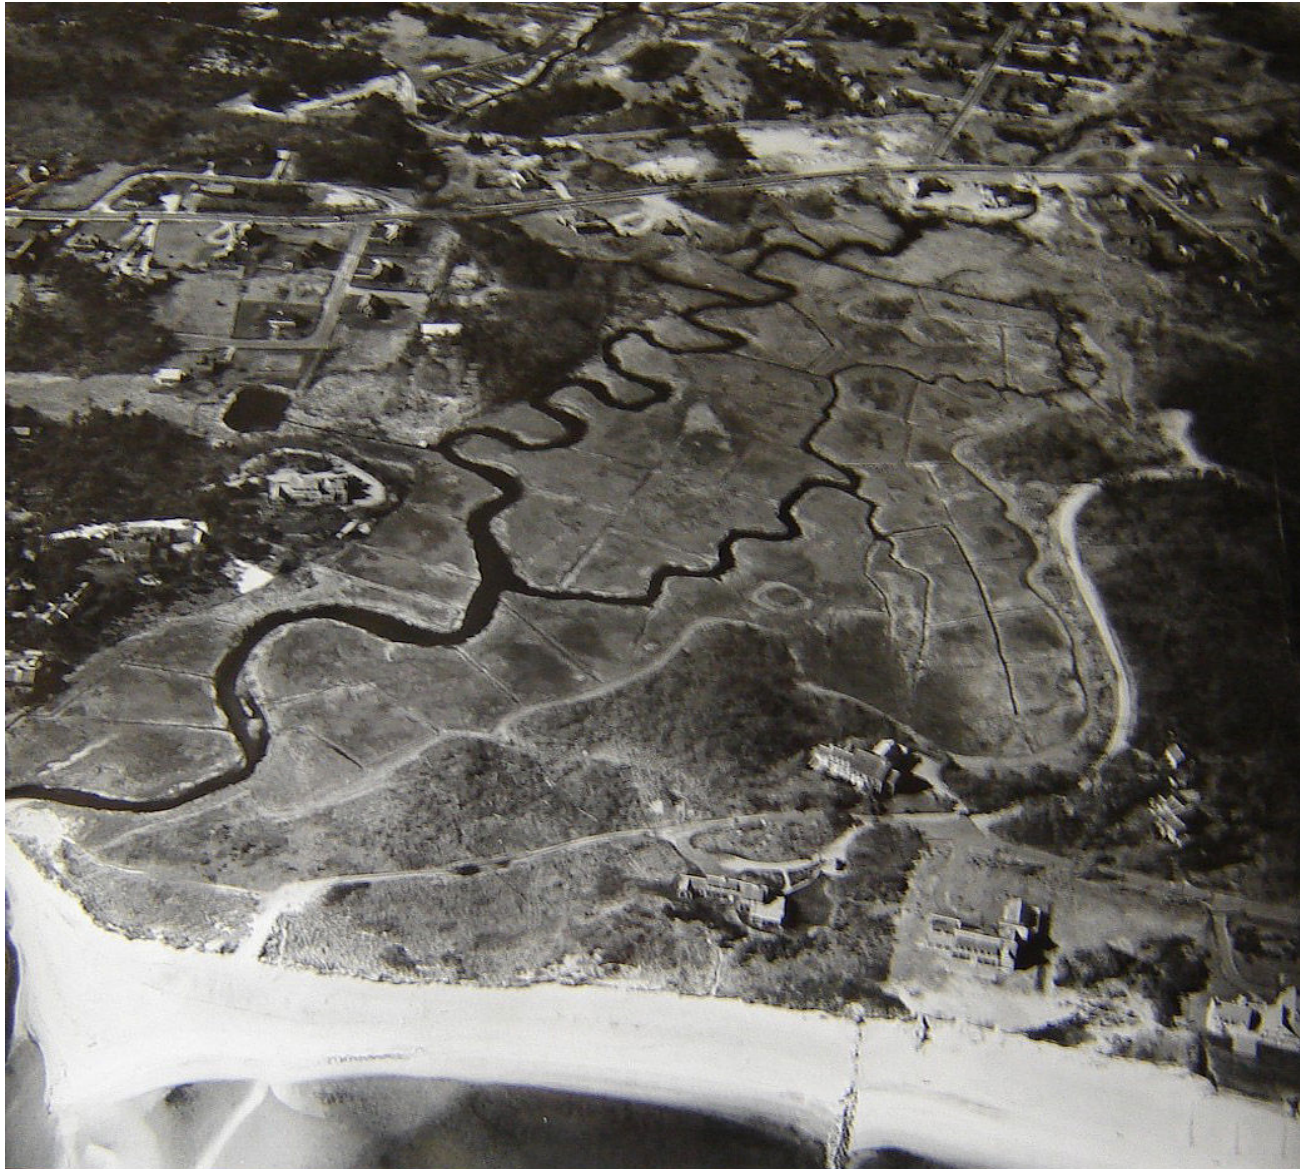
Figure 3. 1964 Aerial Photograph of Andrews River Estuary, Harwich. Andrews River was dredged in 1968-1969 to create Saquatucket Harbor. The southern portion of the Cold Brook cranberry bog system is shown in the upper portion of the photo.

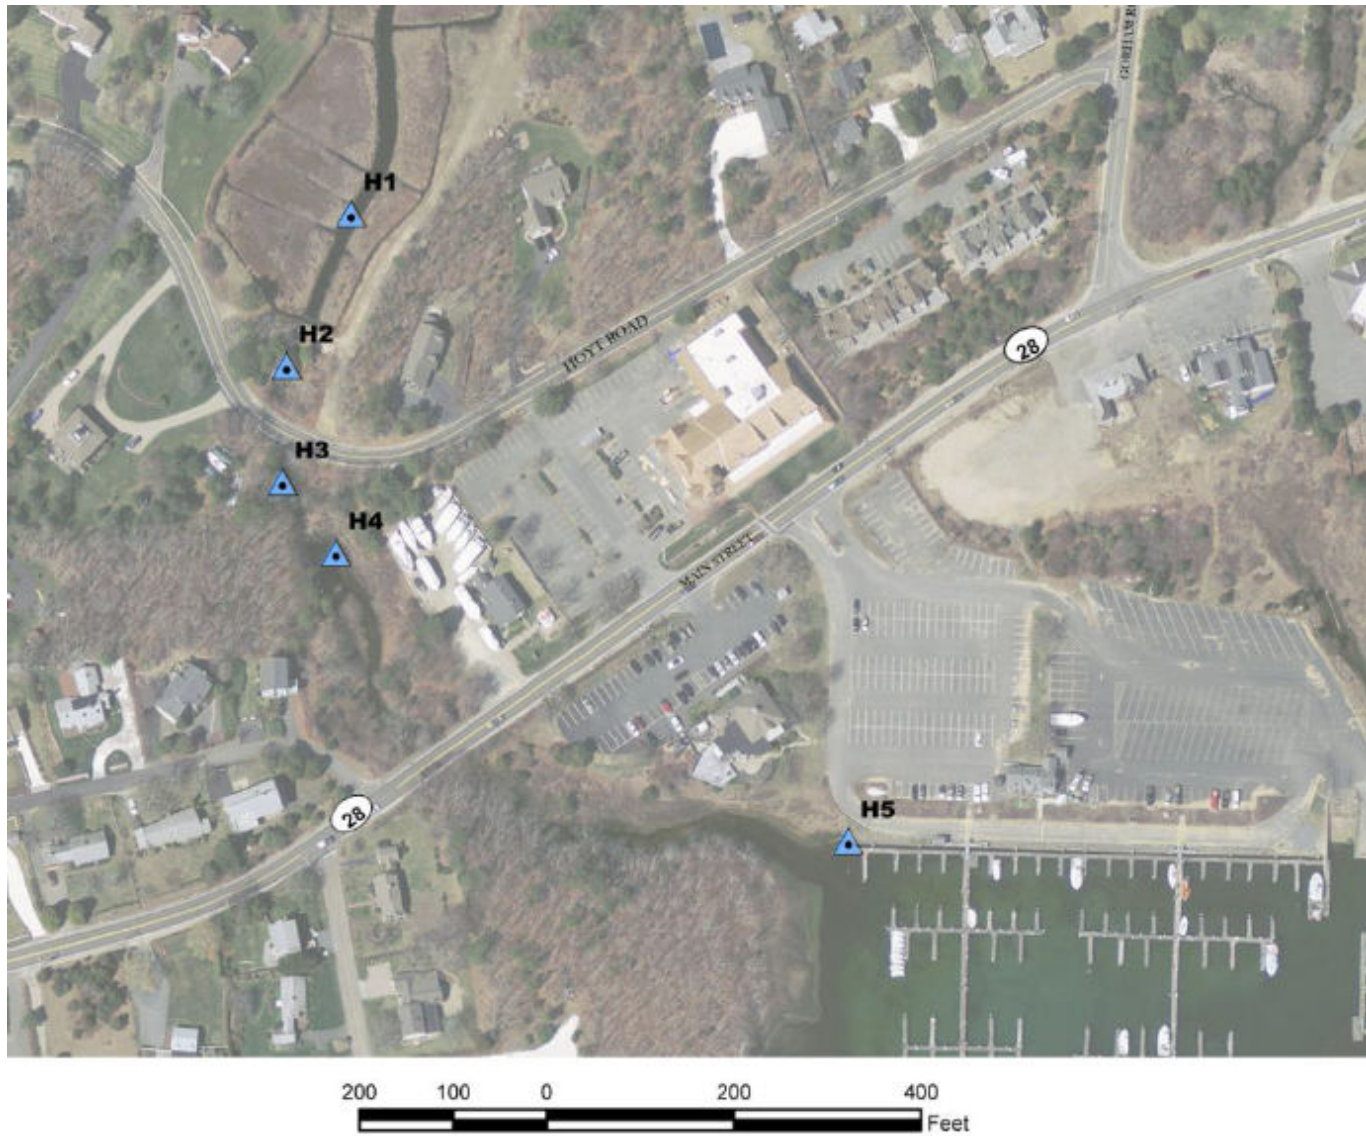
Figure 5. Cold Brook tide gauges locations for Geosyntec Consultants. Gauges were installed and recorded between May 12 and June 10, 2011 using 6 minute recording intervals. Modified from Figure 4 in Geosyntec Consultants (2011).

- Installed 5 water level recorders with 6 minute recording intervals for 29 days between May 12 and June 10, 2011. Recorders were installed in an area generally between the bog and Saquatucket Harbor with a primary focus on the impact on tidal elevations of the dam between Route 28 and Hoyt Road (Figure 5).
